Mr. James Smith
Rotary Kiln and Dryer Metal of America

RE: Plant Evaluation of Rotary Dryer Equipment

ASPHALT DRYER – PLANT EVALUATION

ASPHALT DRYER – Joliet PLANT EVALUATION

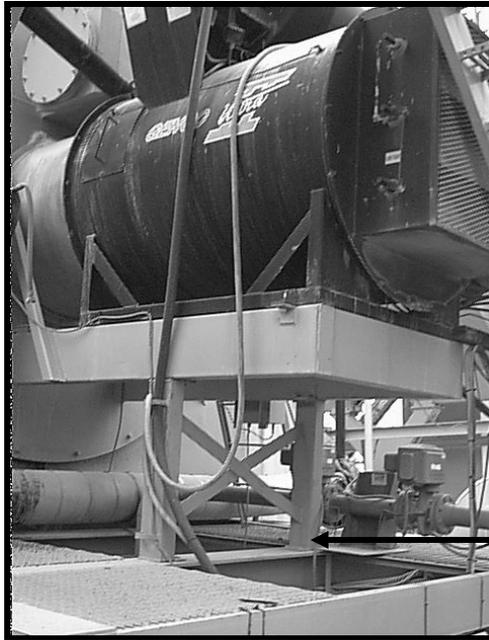
Overall, the unit appears to be running satisfactorily with some vibration being created by the burner. The vibration has caused timing marks across the face of the discharge tire with the trunnions mirroring the tire.

Vibration from the Burner is being transmitted directly to the dryer support frame, affecting the tires & trunnions

Isolate the burner and its support assembly from the dryer frame using support legs and cross bracing independent of the main dryer frame assembly.

It appears there is room to install support legs and cross bracing at each corner of the burner support frame to ground elevation. Some engineering will need to be accomplished regarding footing requirements and steel sizing to sufficiently support the burner.

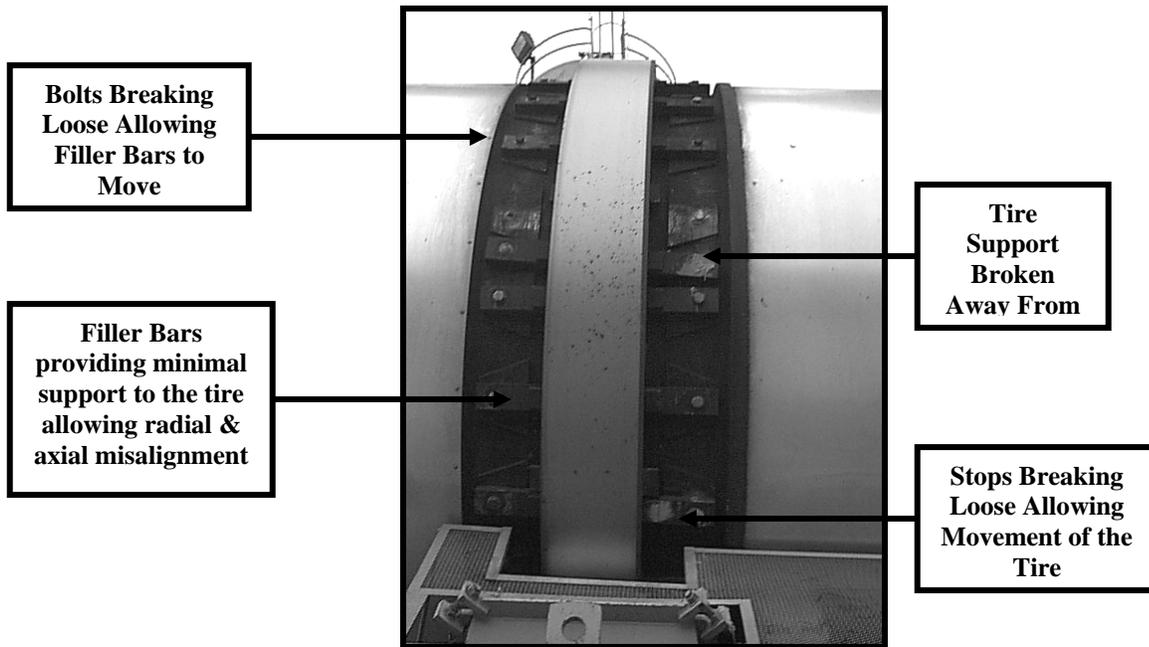
The tire support system at the inlet tire is failing and should be looked at for replacement at the next opportunity.

Remove the existing anti-rotation tire support design, and replace it with a fully supported slip tire design. This design provides much better support to the underside of the tire, preventing premature movement of the tire in the axial & radial alignment to the centerline of the drum. Removal of the anti-rotation stops will stop the tire from peeling away the filler bars every time the tire attempts to creep.

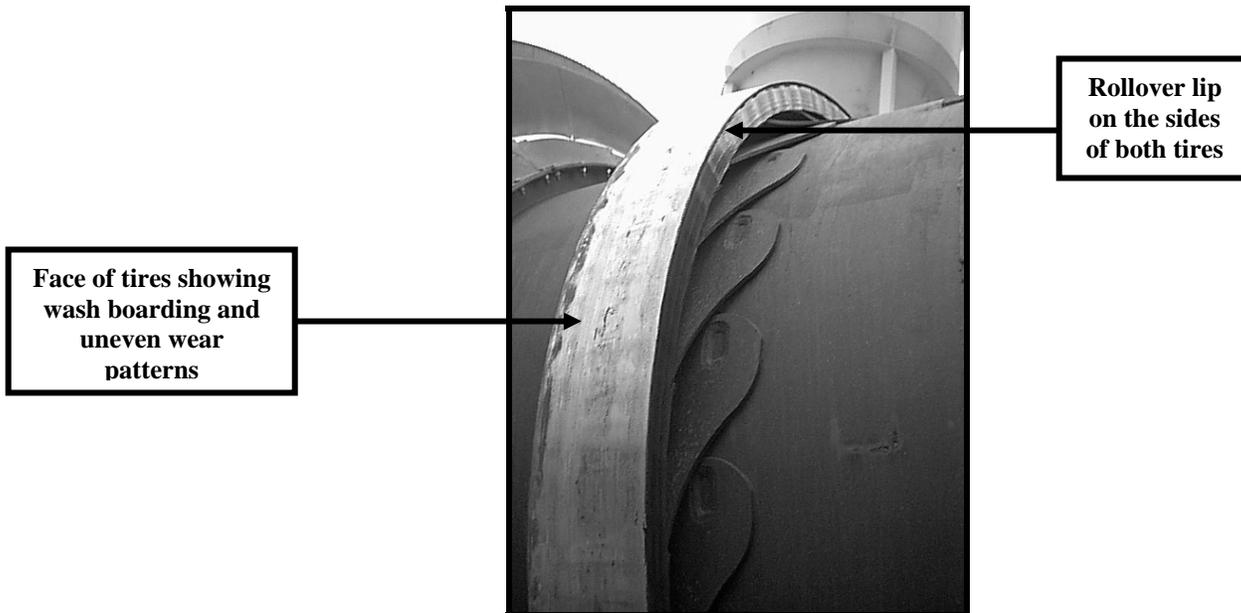
Both tires are showing considerable wear with approximately ½” rollover on the sides of the tires. The trunnions appear to be worn out. Testing of the tires and trunnions revealed the following information:

TIRE HARDNESS: 285/325 BRINEL

TRUNNION HARDNESS: 475/550 BRINEL

The trunnions should be replaced with new or reconditions assemblies. Bearings should be replaced and housings cleaned, inspected and replaced as necessary.

Both tires should be ground to reestablish axial & radial alignment to the centerline of the drum, with taper, concave or convex conditions removed from the faces of the tires.

Alignment of the vessel should be accomplished while running the “average” production load, allowing for movement of the drum for extremes on both ends of the spectrum. Some contact with the thrust idlers is unavoidable, but should only be light contact and not supporting the entire weight of the drum and the material.

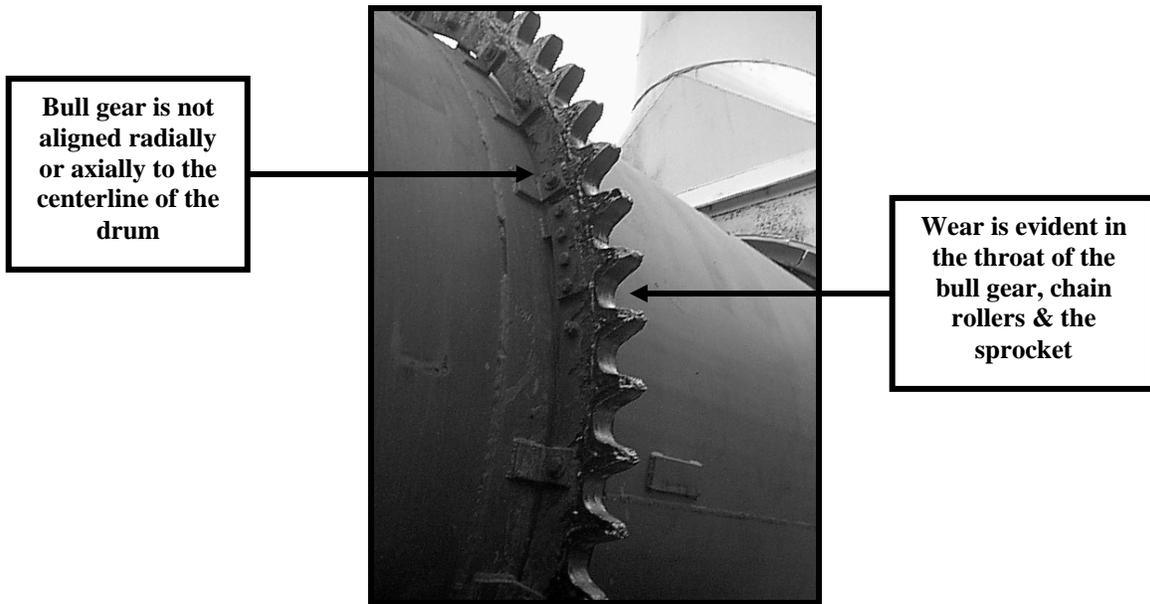
The bull gear, chain and sprocket are exhibiting considerable wear. Some noise from the drive train is being transmitted to the discharge tire, causing a washboard effect on the face of the tire. The bull gear is bolted to the drum and does not appear to be correctly aligned. This condition causes the chain assembly to tighten and loosen, as the drum is rotated causing loading and unloading to occur across the entire drive assembly. Premature failure of the chain, sprocket, bull gear, or gearbox could result.

Replace the bull gear, chain and sprocket as a unit. Align the bull gear to the centerline of the vessel negating the loading and unloading of the drive assembly.
